***Historical Characterization
and Data Gaps***

***Old Bremerton Gasworks Property
1725 Pennsylvania Avenue
Bremerton, Washington***

***Prepared for
Washington State
Department of Ecology***

***May 2, 2007
17330-07***

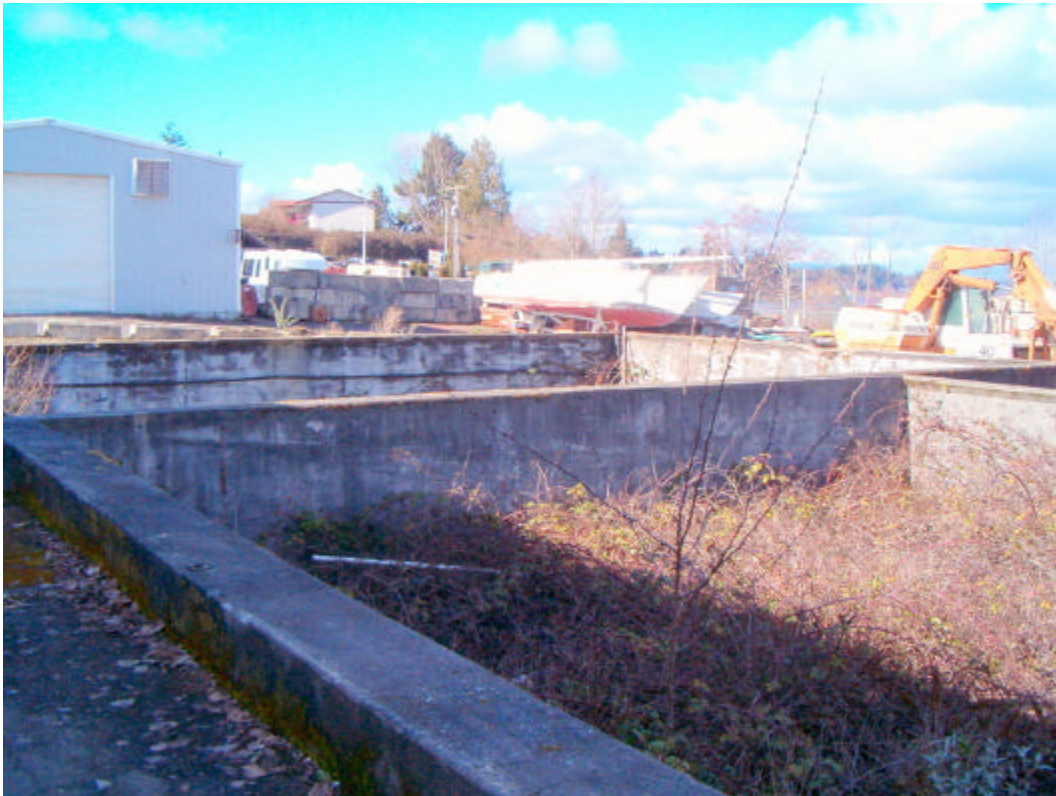
Photograph 1 - View of the secondary containment structures at the Sesko parcel, looking northwest.

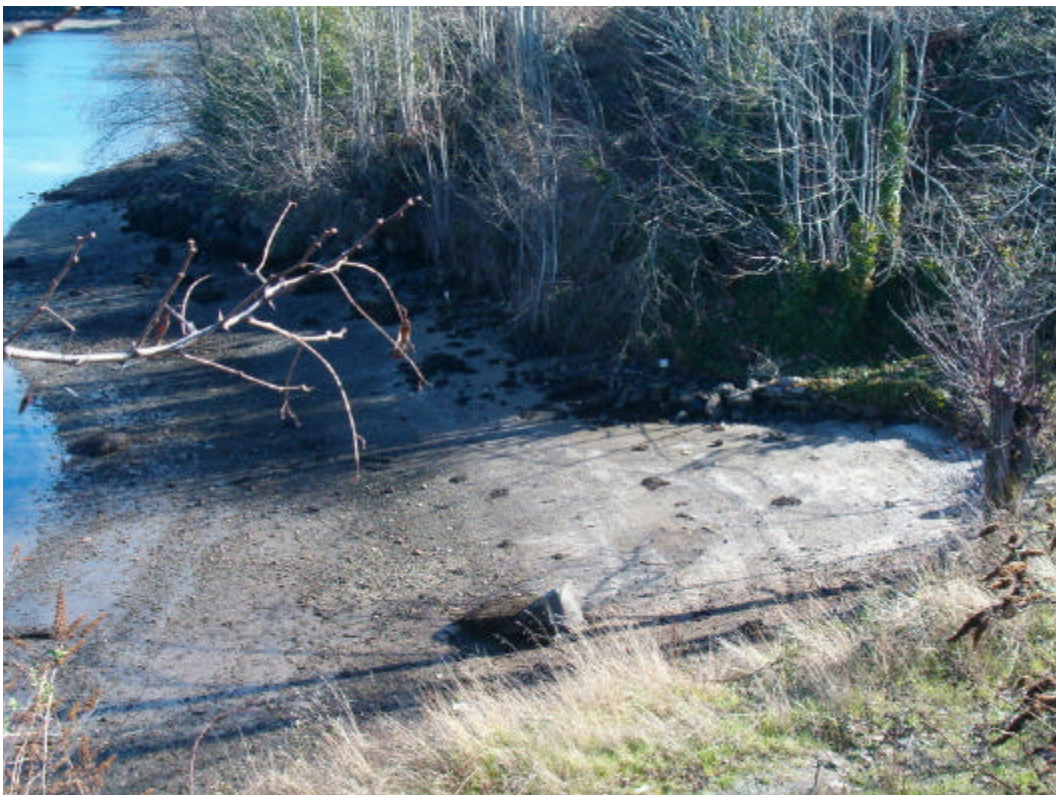
Photograph 2 - View of the beach and apex of gully at the Sesko parcel, looking east.

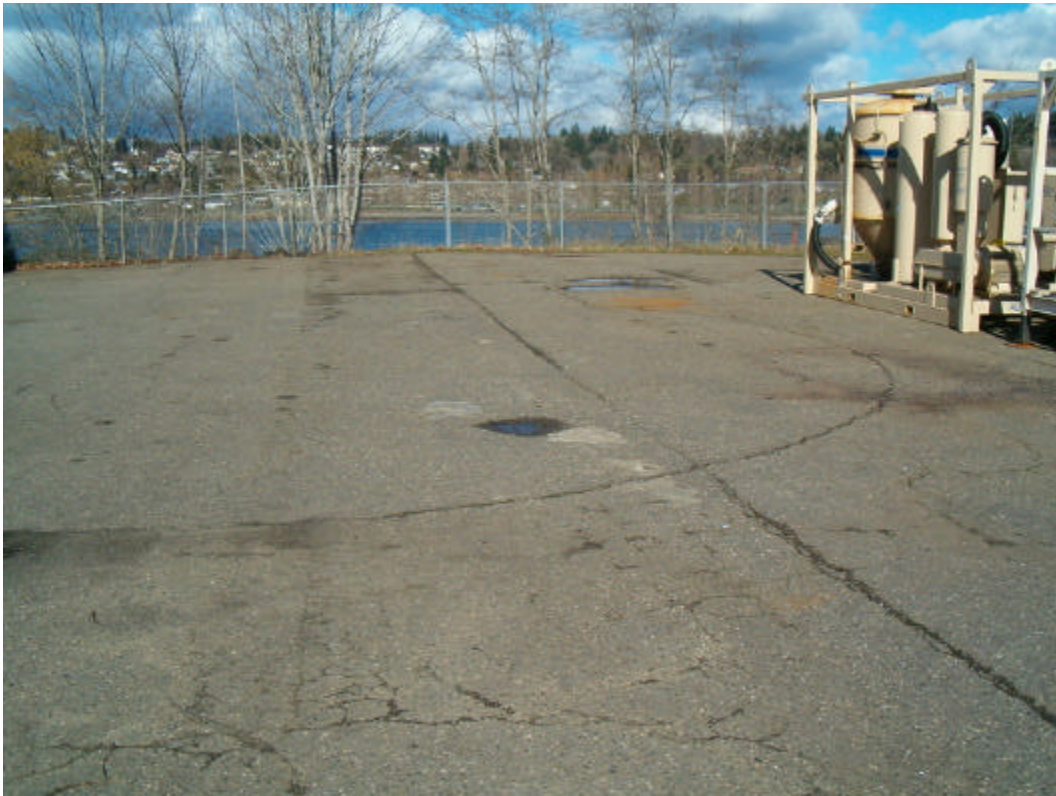
While walking through the former Gasworks parcel, Mr. Bartlo pointed out a large crack in the asphalt in the shape of a circle. He indicated this was the location of one of the former gasworks ASTs. Also he indicated that a number of logs apparently treated with creosote had been dumped along the slope to the shoreline by the gasworks plant. He also pointed out the ship and ballast tanks currently tied to the shoreline were the property of William Sesko, now deceased. He indicated Mr. Sesko used to buy "junk" at auctions, and the ship and tanks appeared one day tied up to the shoreline.

Photograph 3 - View of circular-shaped crack (location of former gas holder tank) at the Sesko parcel, looking north.

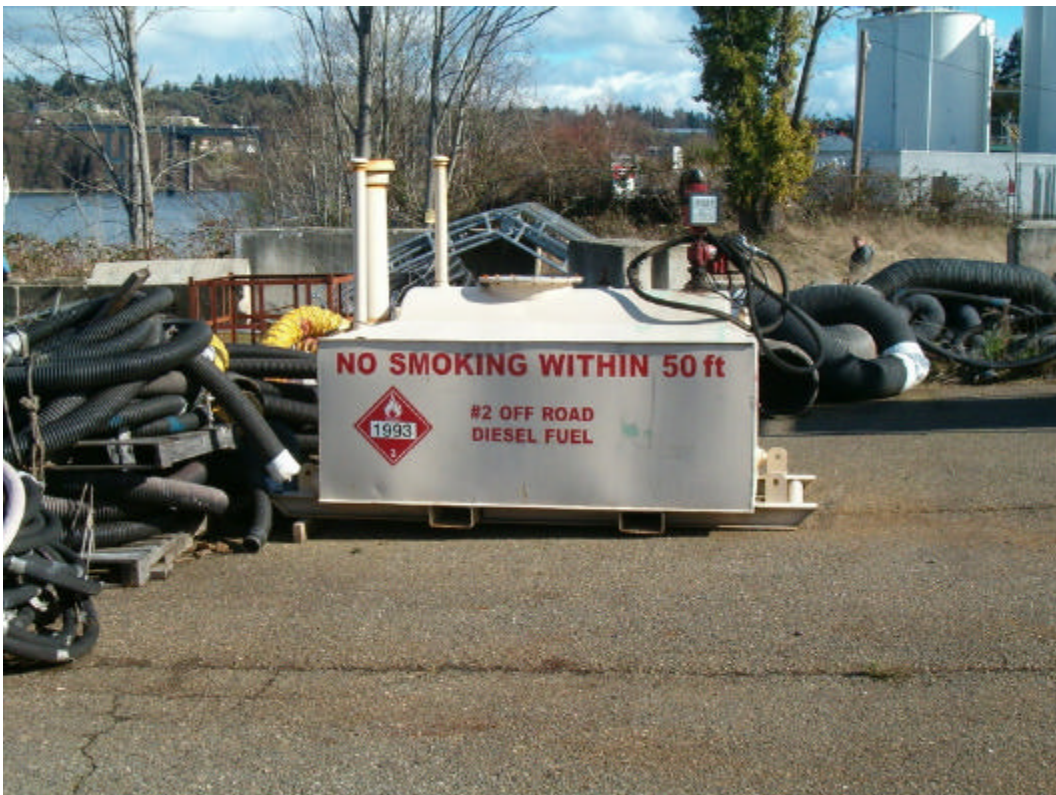
Photograph 4 - View of the portable diesel AST used by BAE at the Gasworks parcel, looking east.

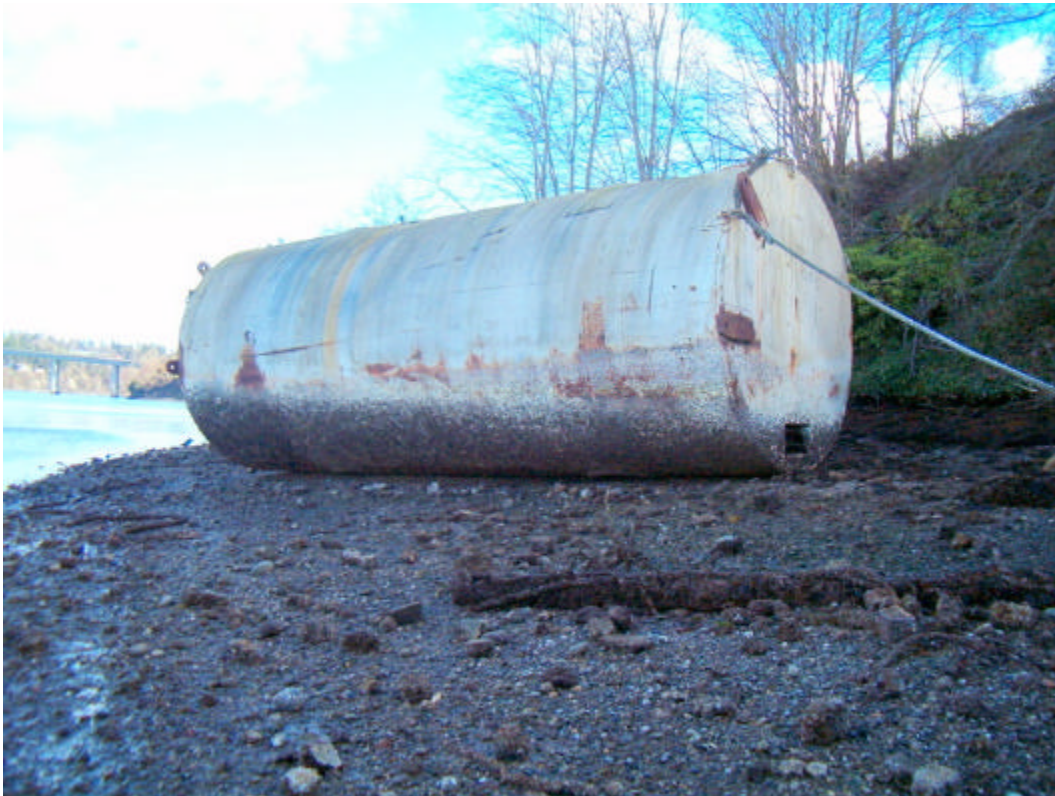
Photograph 5 - View of one of the “ballast tanks” along the Gasworks parcel shoreline, looking east.

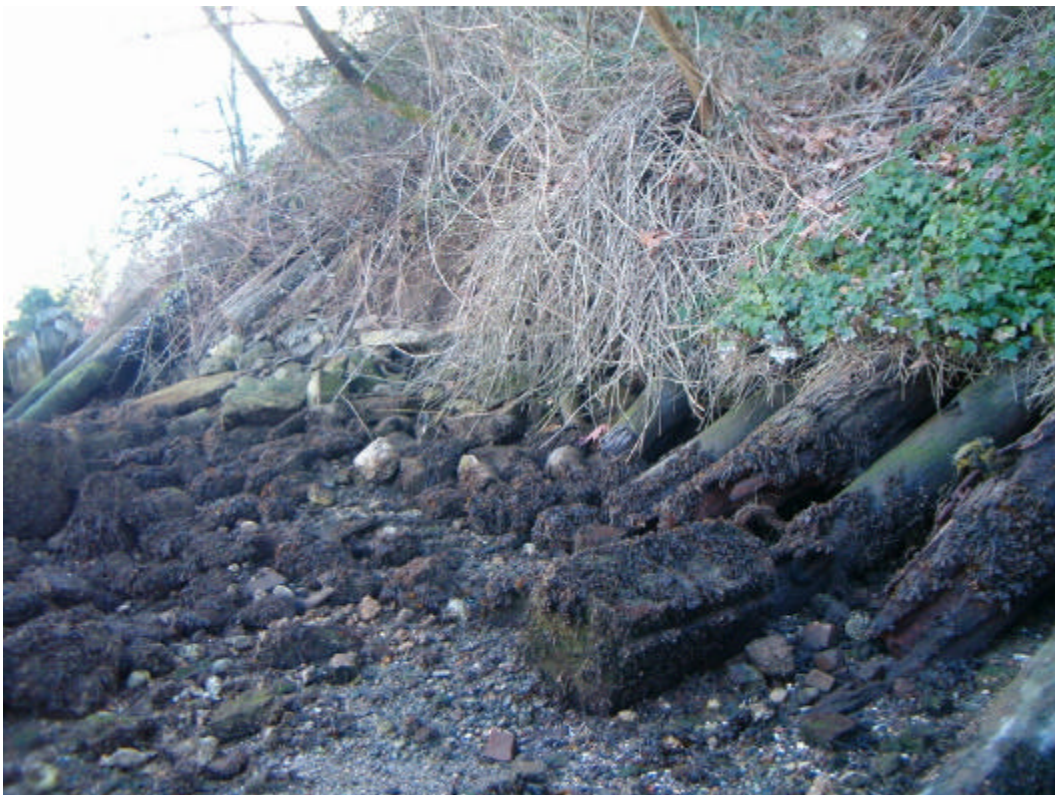
Photograph 6 - View of creosote-covered timbers on the shoreline slope of the Gasworks parcel.

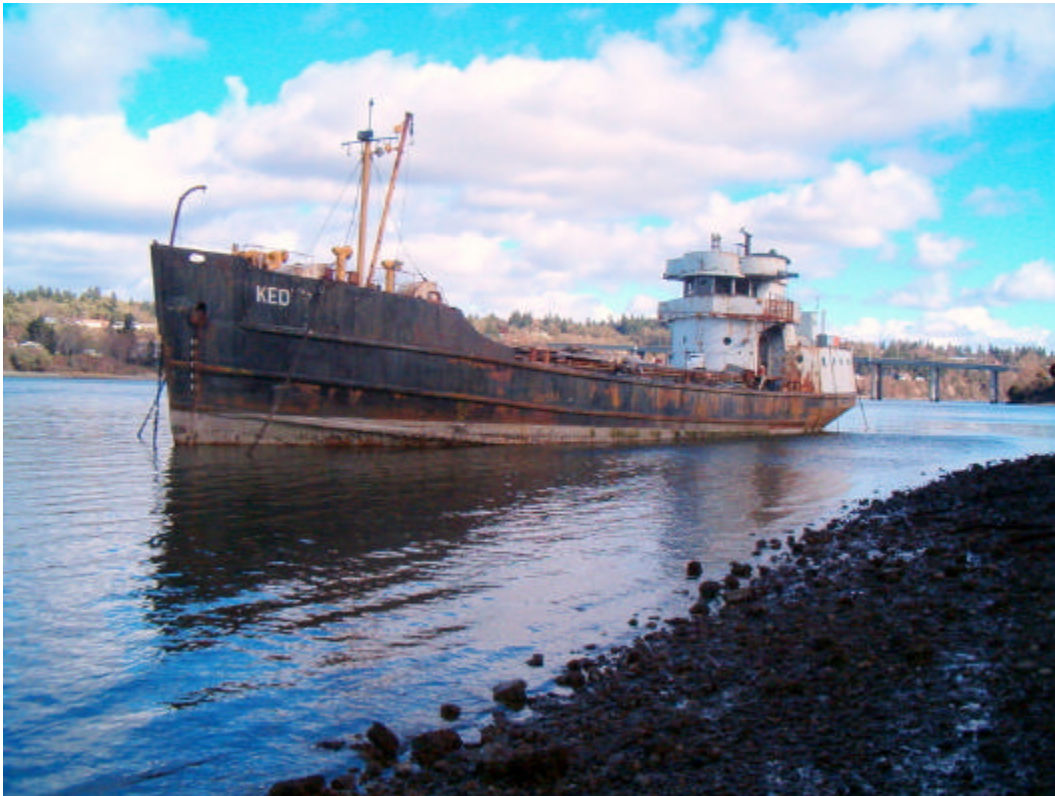
Photograph 7 - View of the *KED* anchored along the Gasworks parcel shoreline, looking northeast.

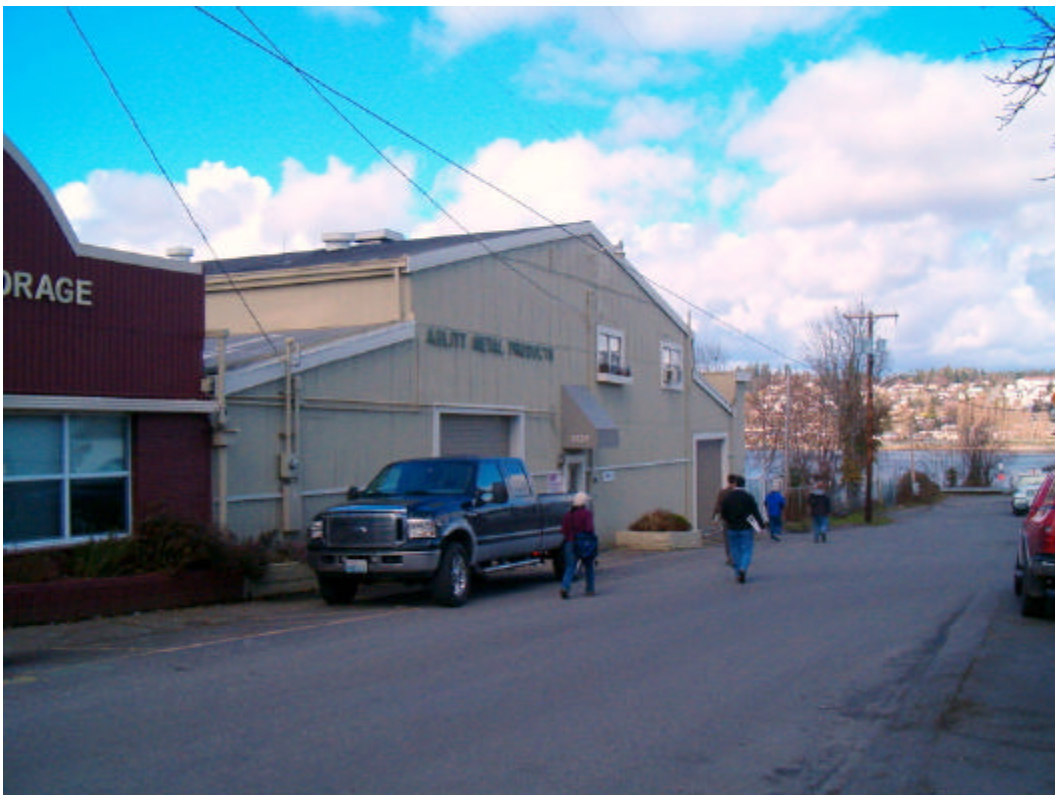
Photograph 8 - View of the original building (Pennsylvania Avenue) at the Penn Plaza Industrial Park, looking northwest.

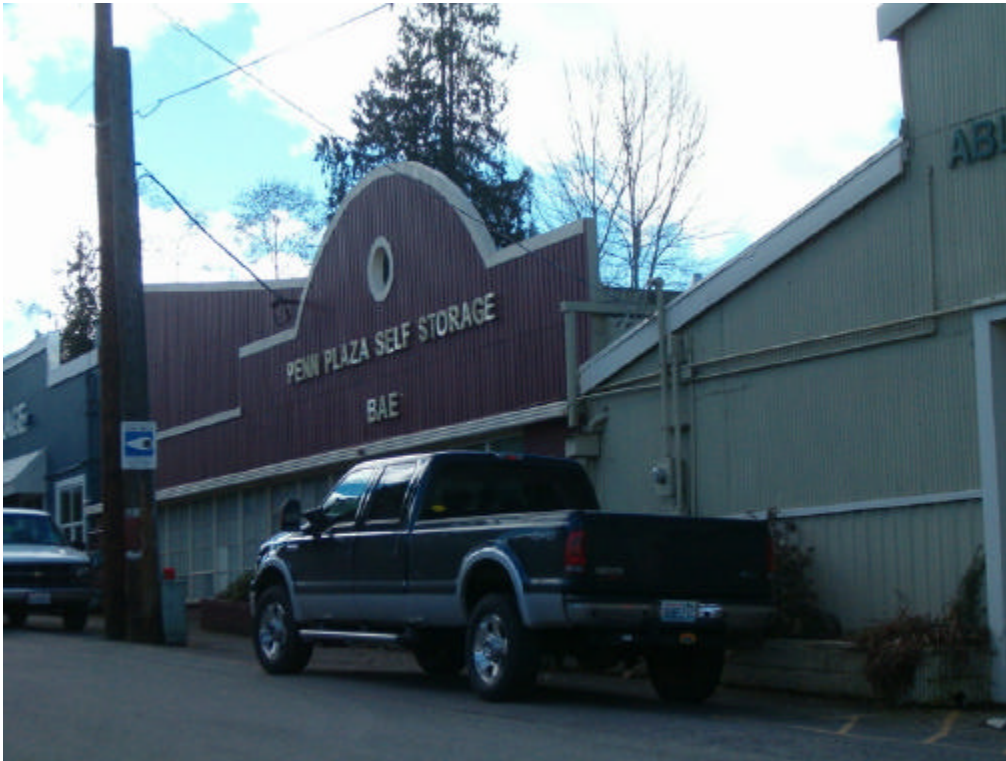
Photograph 9 - View of the second addition to the original building (Pennsylvania Avenue) at the Penn Plaza Industrial Park, looking southwest.

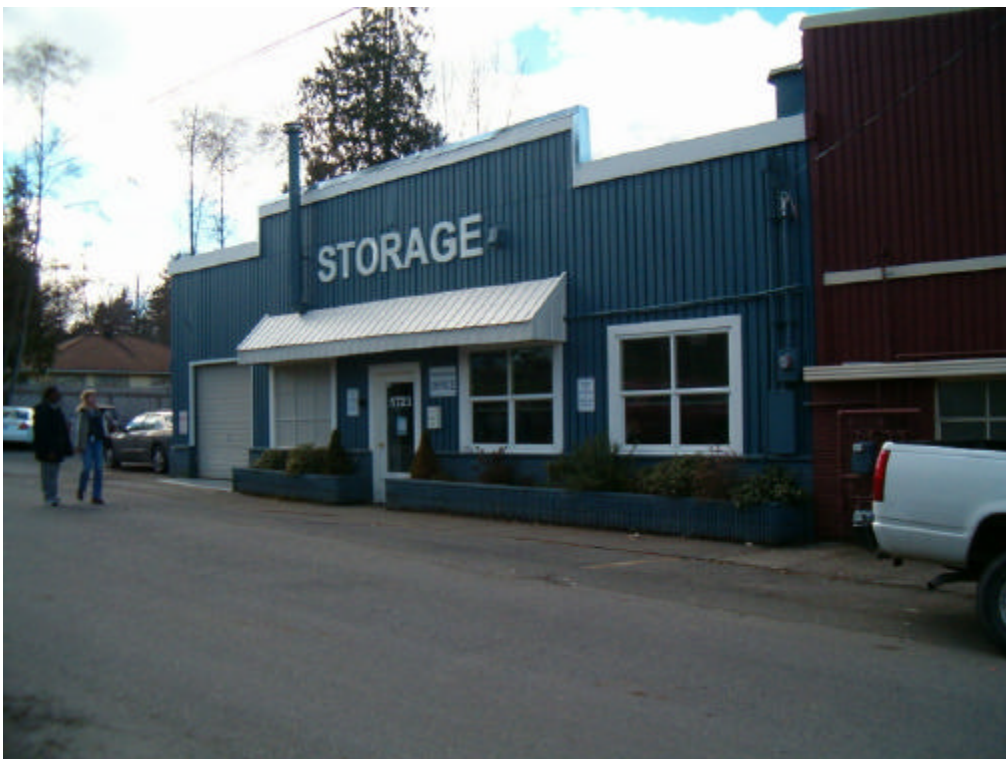
Photograph 10 - View of the third and last addition to the original building (Pennsylvania Avenue) at the Penn Plaza Industrial Park, looking southwest.

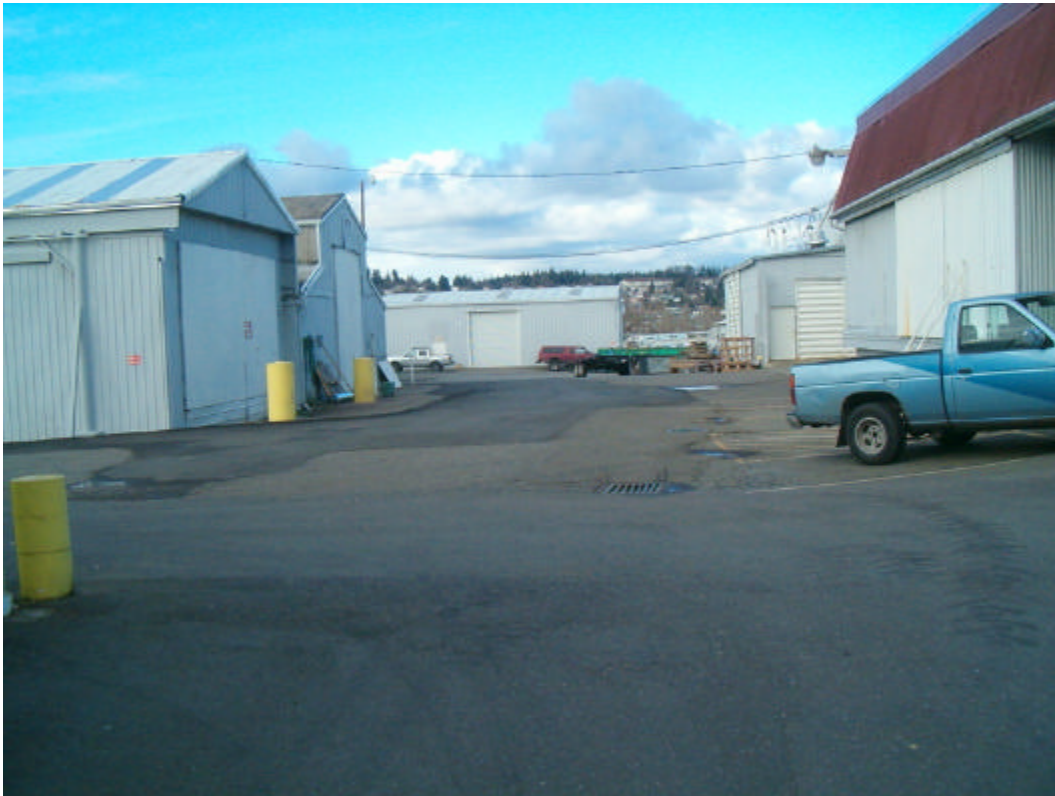
Photograph 11 - View of the parking area between the buildings at the Penn Plaza Industrial Park, looking north. Notice the catch basins along the center of the drive.

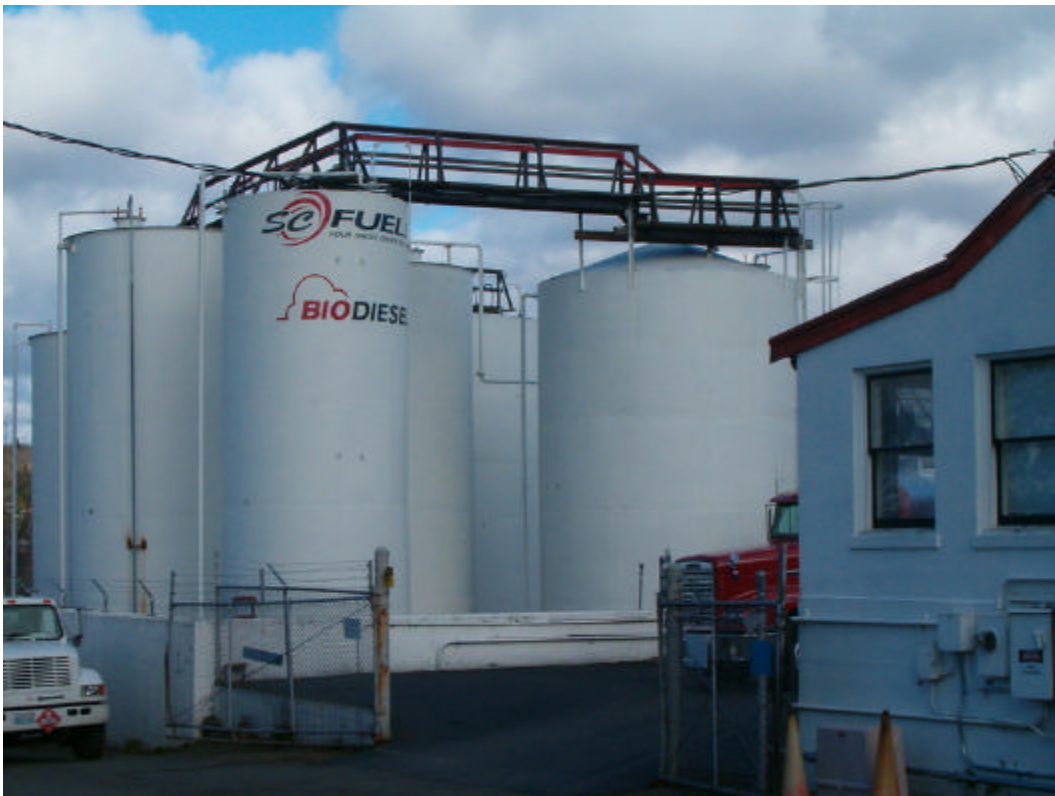
Photograph 12 - View of the bulk fuel ASTs and secondary containment at SC Fuels - Biodiesel on the northeast adjacent bulk plant.

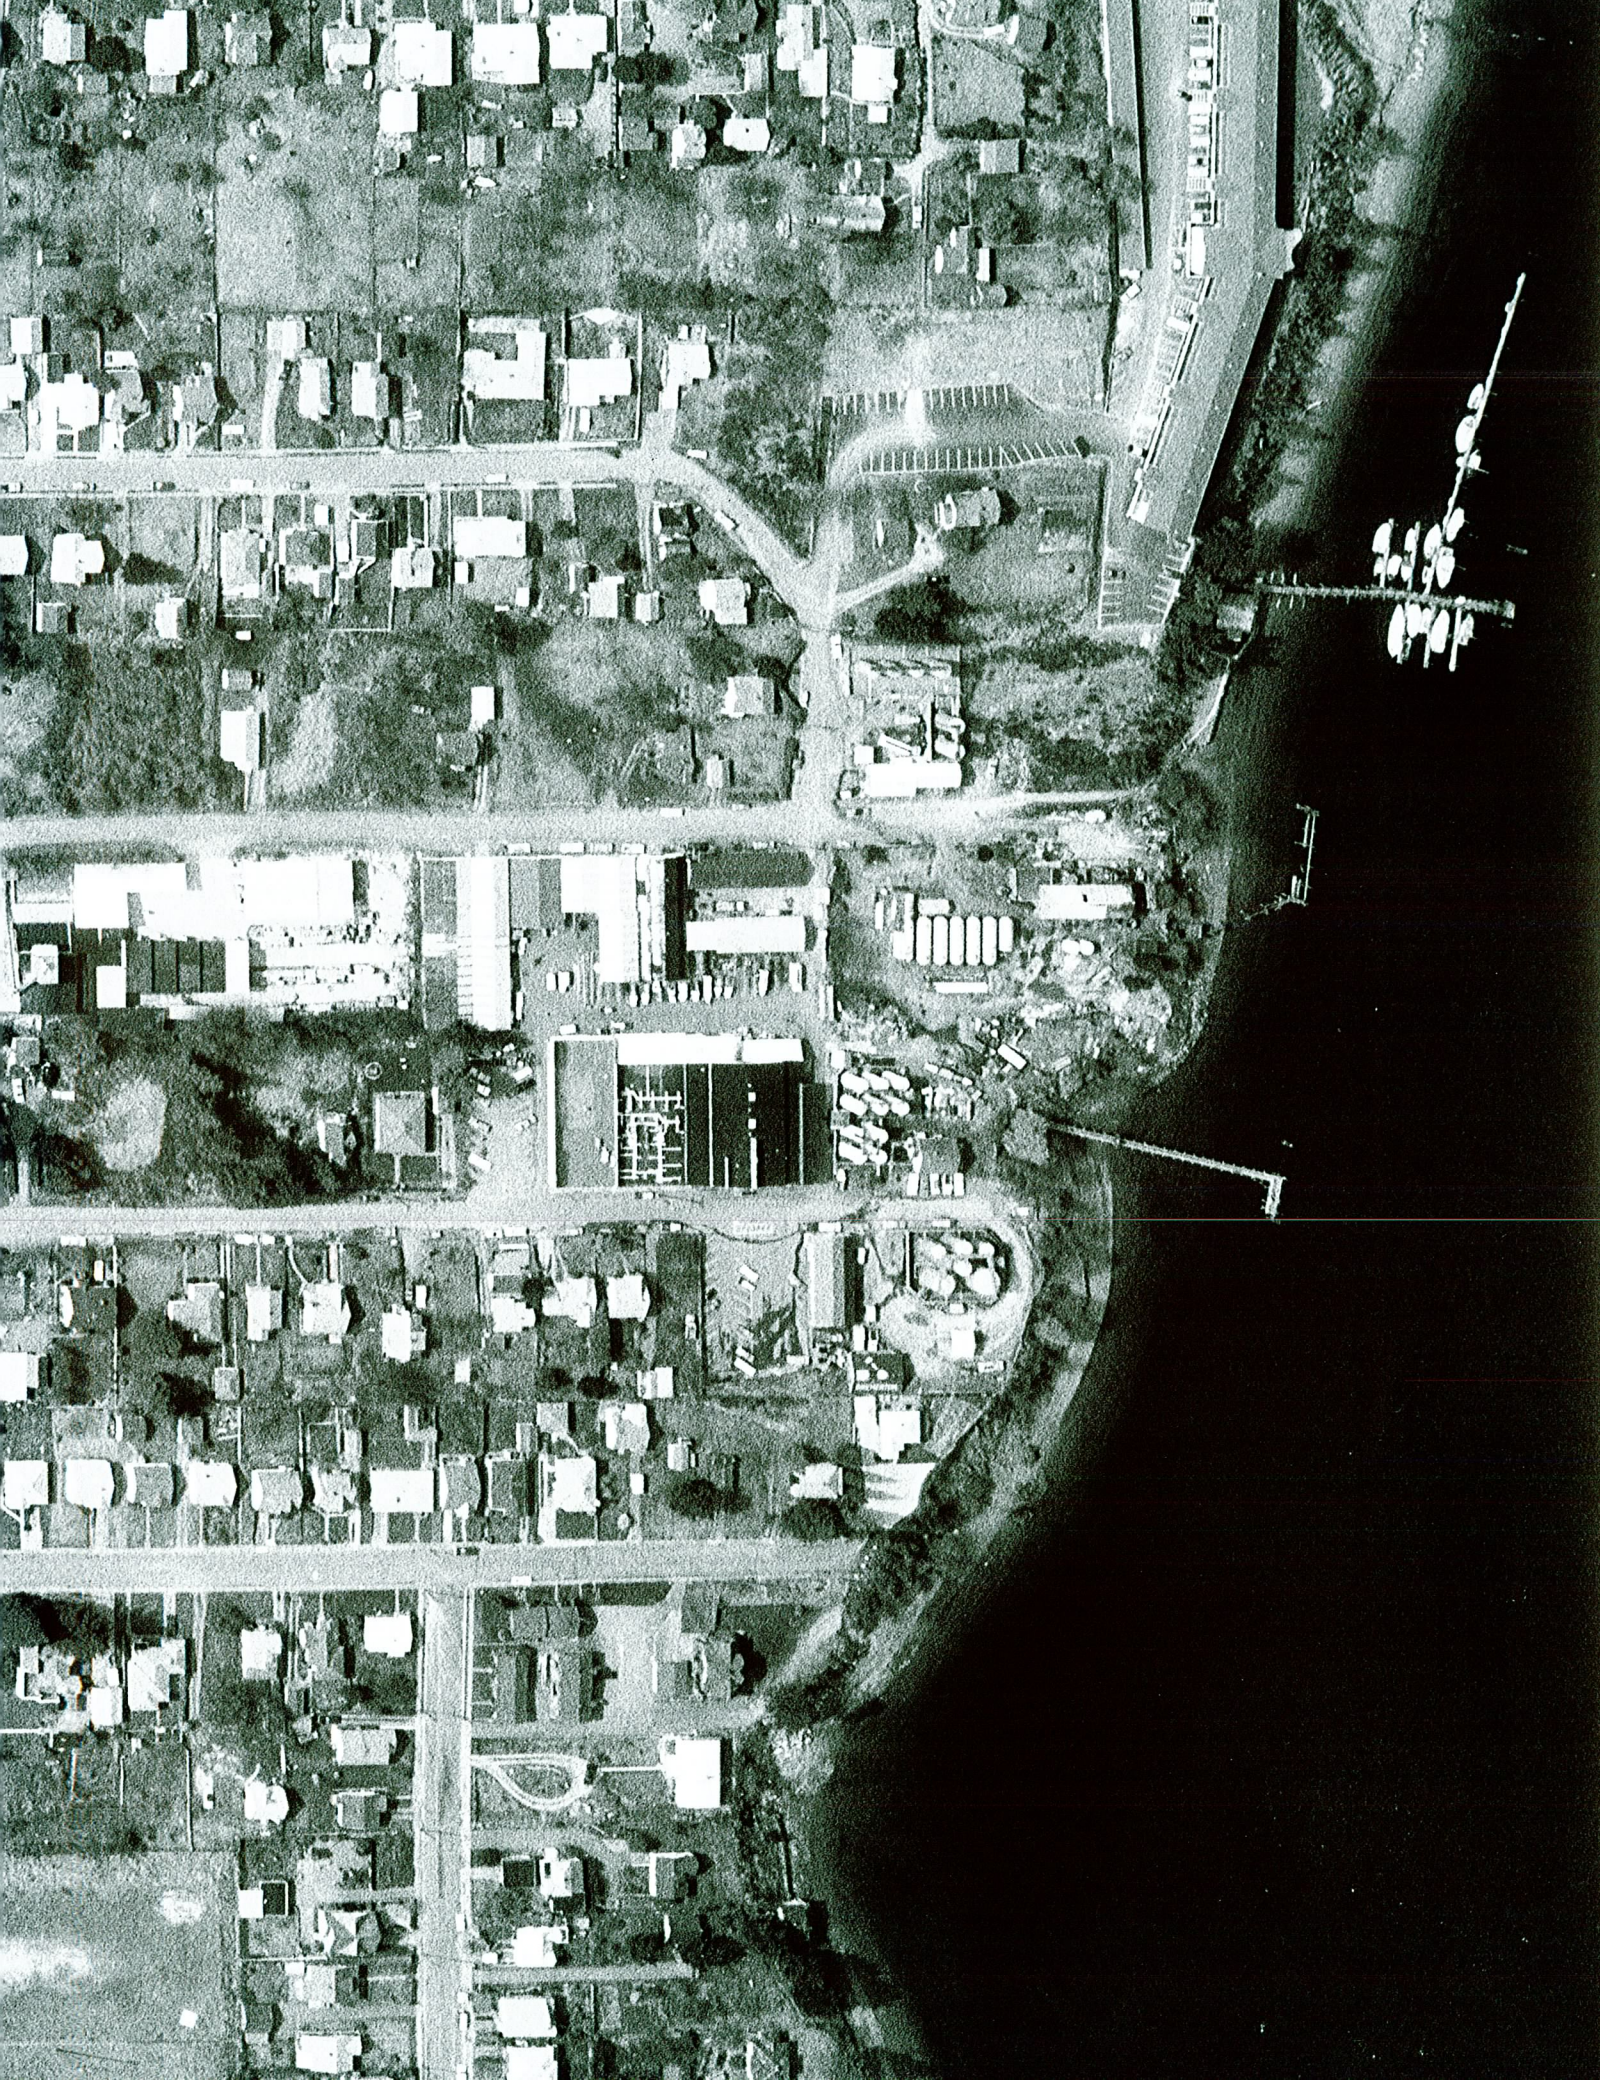
Negative Number	JKM-71	5-32
Year Photographed	3-25-71	
Approx. Scale of Print	1" = 150'	
Order Identification	W.O. # 37188

1971 Aerial Photograph. The piers on the Gasworks and the Sesko parcels are both looking in need of repair and the area around the pier landing on the Sesko parcel appears to have been filled-in and regraded. What appears to be debris

and some unidentified objects were also observed along the border between the Sesko and the Gasworks parcels. In addition, the area of the northeast corner of the Gasworks parcel (along the slope to the shoreline) also appears to have been filled in.

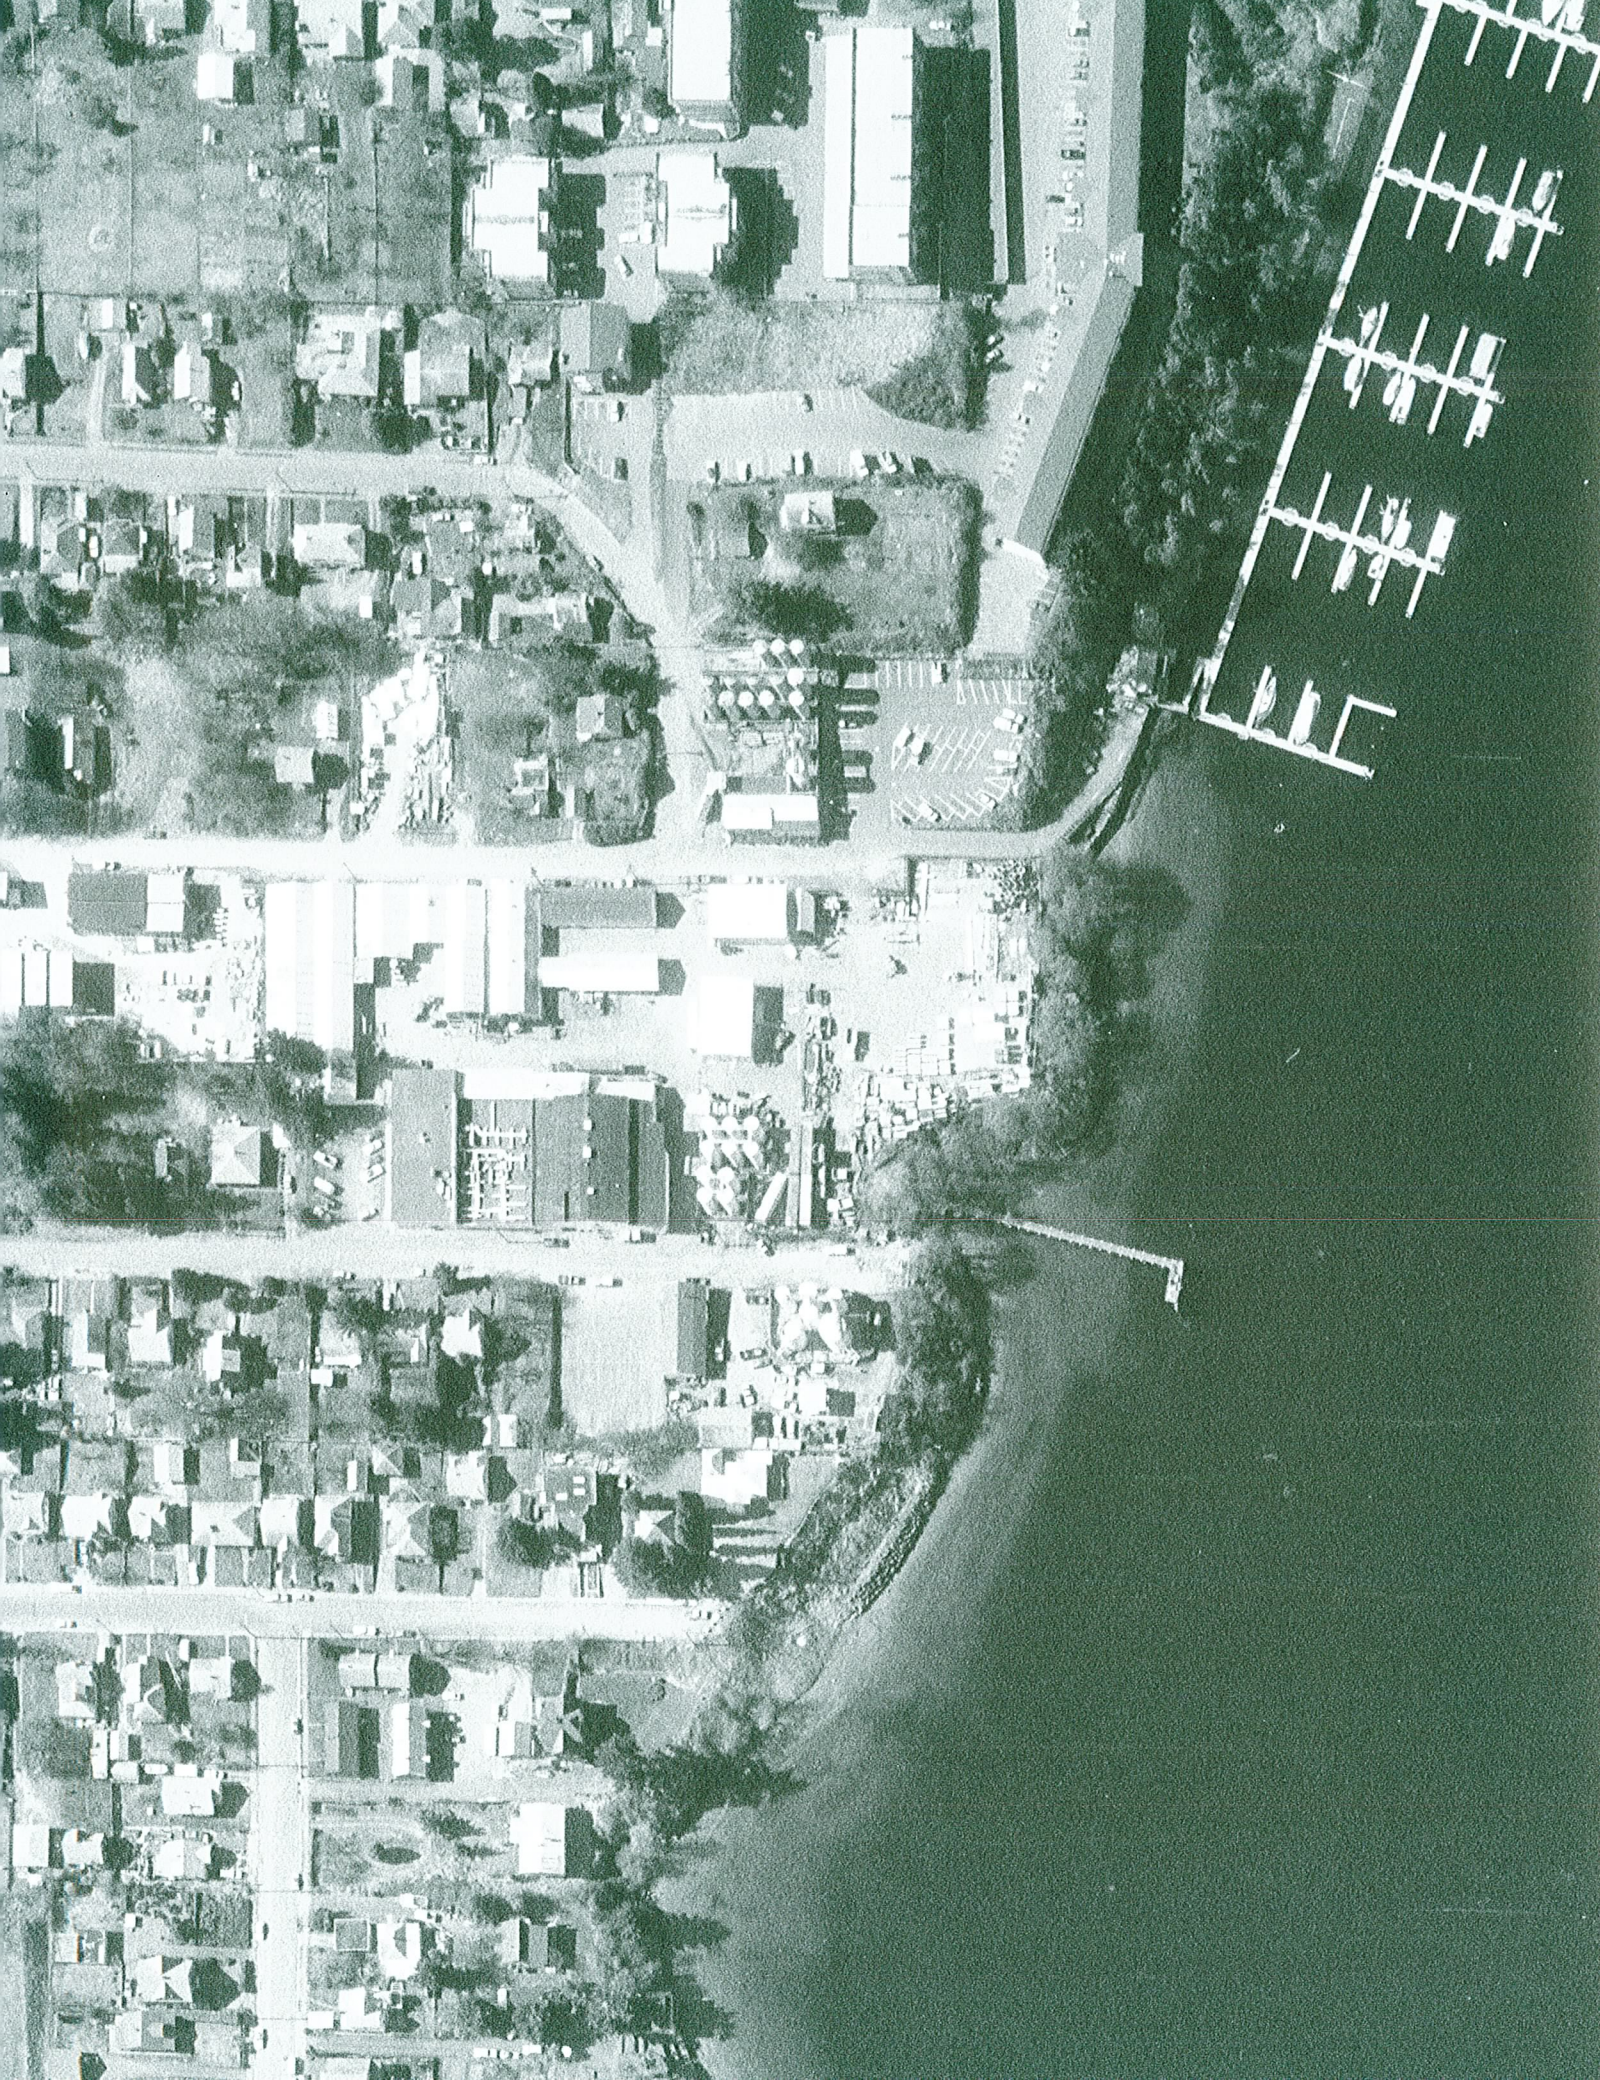
Negative Number	JKM-85	12-27
Date Photographed	3-18-85	
Approx. Scale of Print	1" = 150'	
Other Identification	W.O. # 37188

1985 Aerial Photograph. This photograph indicates the facility is similar to what it looked like in 1977 except that the north section of the Gasworks parcel is paved and used for parking and materials storage. The pier directly north of the Gasworks parcel has been removed and vegetation has grown along the sloped shoreline and the Sesko parcel. The building north of the secondary containment areas on the Sesko parcel has also been removed and replaced by several semi trailer containers.

The secondary containment area on the northwest adjacent bulk plant has been expanded and an additional nine ASTs have been installed. The remainder of the facility appeared to be in similar conditions to the 1971 photograph.
